## Installation and Maintenance Manual for SPANCO® (WC) Wall Cantilever Jib Cranes

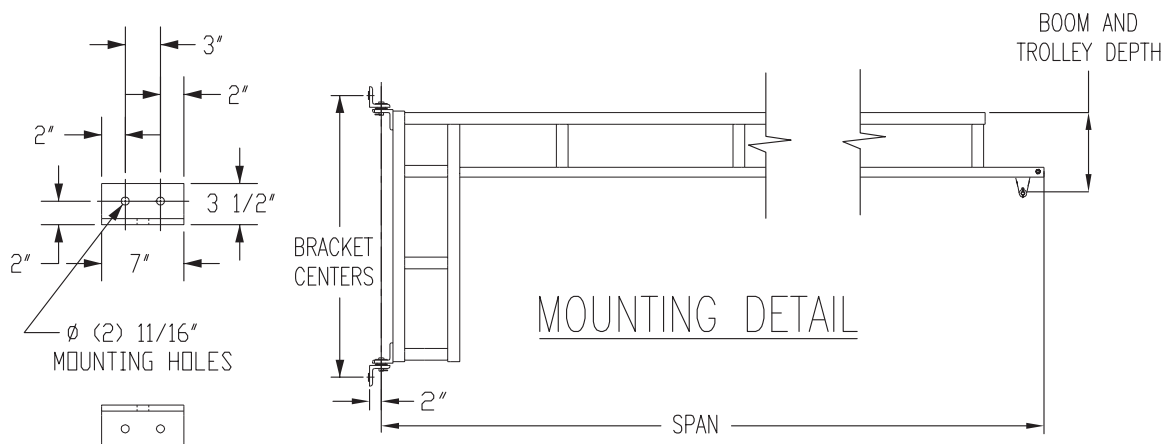
1. Refer to **Tables (1) and (2)** and locate the dimensions of the specific Model WC jib crane to be installed.

TABLE (1)	BOOM AND TROLLEY DEPTH						
	SPAN						
CAPACITY	4'	6'	8'	10'	12'	14'	16'
100	6 - 1/2"	6 - 1/2"	11 - 1/4"	11 - 1/4"	13 - 1/4"	13 - 1/4"	13 - 1/4"
150	6 - 1/2"	6 - 1/2"	11 - 1/4"	11 - 1/4"	13 - 1/4"	17"	17"
250	6 - 1/2"	11 - 1/4"	11 - 1/4"	13 - 1/4"	17"	17"	17"
500	12 - 5/8"	12 - 5/8"	15"	15"	17"	20 - 3/16"	20 - 3/16"
1000	14 - 3/16"	14 - 3/16"	14 - 3/16"	17 - 1/16"	20 - 3/16"	24 - 1/8"	24 - 1/8"

TABLE (2)	BRACKET CENTERS						
	SPAN						
CAPACITY	4'	6'	8'	10'	12'	14'	16'
100	36"	36"	36"	36"	48"	48"	48"
150	36"	36"	36"	36"	48"	60"	60"
250	36"	36"	36"	48"	60"	60"	60"
500	36"	36"	48"	48"	60"	72"	84"
1000	36"	36"	48"	48"	60"	72"	84"

1. Refer to Tables (1) and (2) and locate the dimensions of the specific Model WC Jib crane to be installed.
2. Please note that the bracket centers in the charts are nominal dimensions only. Do not drill holes according to these dimensions! The crane bushings and washers need a more precise fit, so be sure to follow the remaining steps!

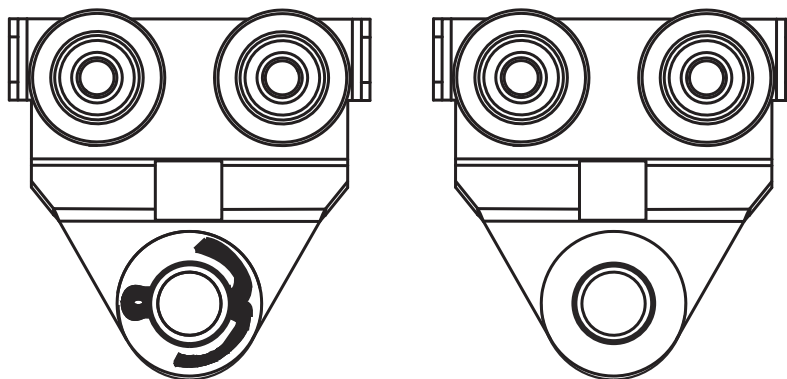
P/N 53-0059

BEND COTTER PIN  
OVER BEFORE USE.  
HOOK MUST BE  
CENTERED ON  
TROLLEY PIN.

DO NOT OPERATE  
HOIST/CRAVE IF  
SPLIT/COTTER PINS  
ARE NOT IN PLACE  
AND PROPERLY BENT  
OVER ON BOTH SIDES  
OF HOIST TROLLEY.

Do not operate hoist or crane if cotter pins are not in place and properly bent over on both sides of hoist trolley. Check regularly that the cotter pins are in place and securing the hoist on the hoist trolley.

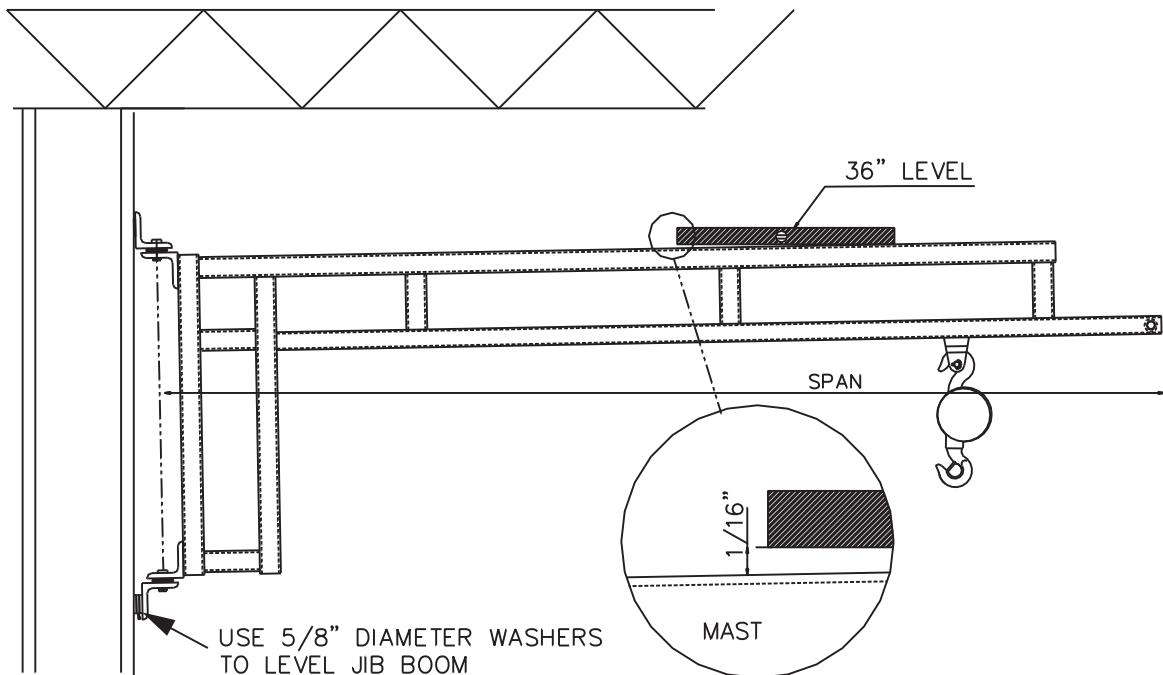
7. Position the unloaded hoist and trolley at the extreme tip of the boom. If desired you may install the boom on a slight incline to compensate for anticipated deflection. If a slight incline is used it should be approximately  $1/16''$  using a 36'' level (see figure). This will keep the incline from exceeding  $1/2$  of the expected total boom tip deflection ( $1/2 \times \text{SPAN} \div 225$ ). If lower washers (shims) are required to level the boom, leave the upper bolts tightened, support crane as needed, and install bottom washers (shims) as needed, then retighten bottom bolts. If upper washers (shims) are required to level the boom, leave the lower bolts tightened, support crane as needed, and install upper washers (shims) as needed, then retighten upper bolts. In the end be sure all 4 bolts are properly tightened (approximately 154 FT•LBS). For a  $5/8''$   $\varnothing$  structural bolt.

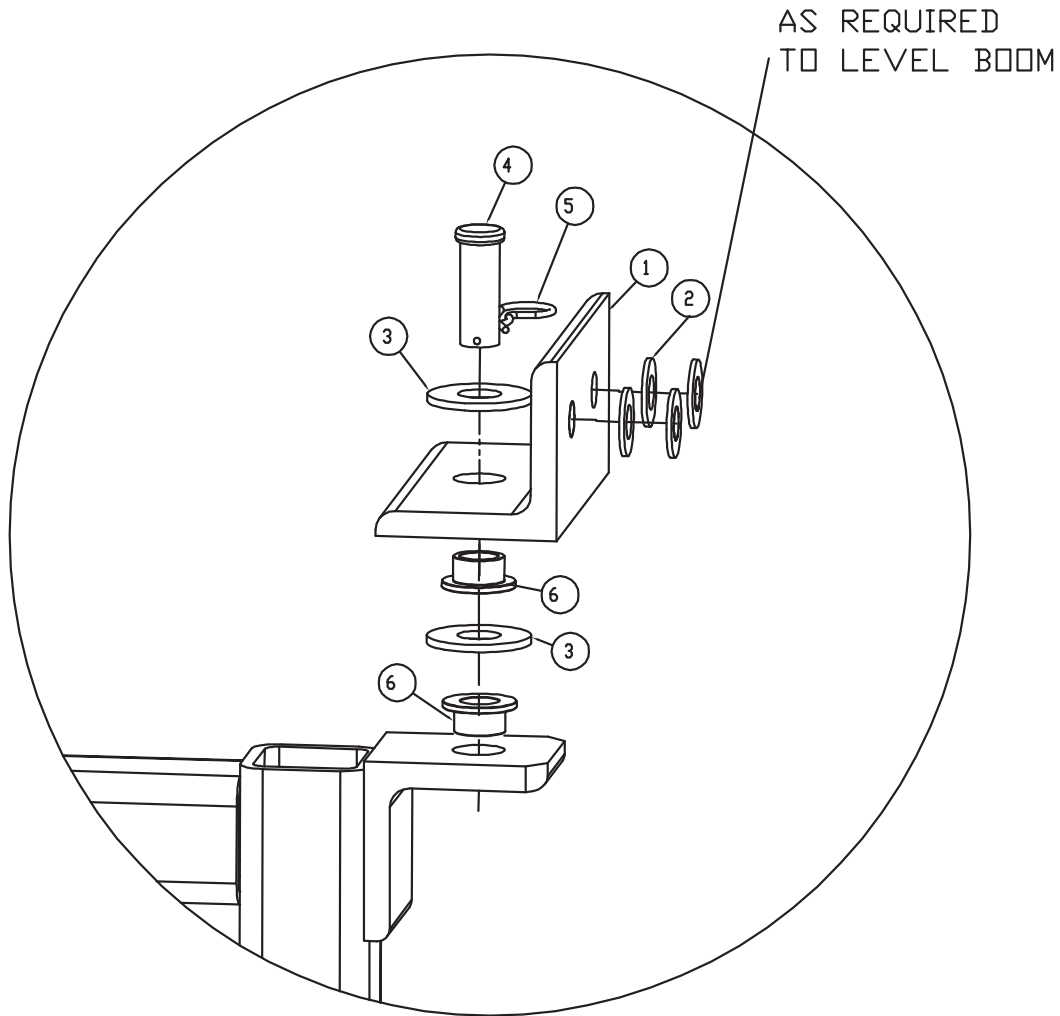
**TOP BRACKET ASSEMBLY:  
 JANUARY 2011 AND EARLIER ONLY  
 WC 100, 150, 250, 500 & 1000 LBS**

**NOTE: As of June 2013, we are no longer using this assembly.  
 The replacement assembly is K-WC-1000-R.**

K-WC-01			
ITEM	QTY.	PART NO.	DESCRIPTION
1	1	WCB1	BRACKET, ANGLE WALL CANTILEVER JIB
2	4	15-0004	5/8" FLAT WASHER
3	2	15-0005	FLAT WASHER, 3/4"
4	1	29-0003	PIN, CLEVIS 3/4" X 2 ZINC PLATED
5	1	29-0006	HAIRPIN COTTERS 5/8" - 3/4"
6	2	26-0009	BEARING, FLANGE 3/4"ID 841 BRNZ OILITE

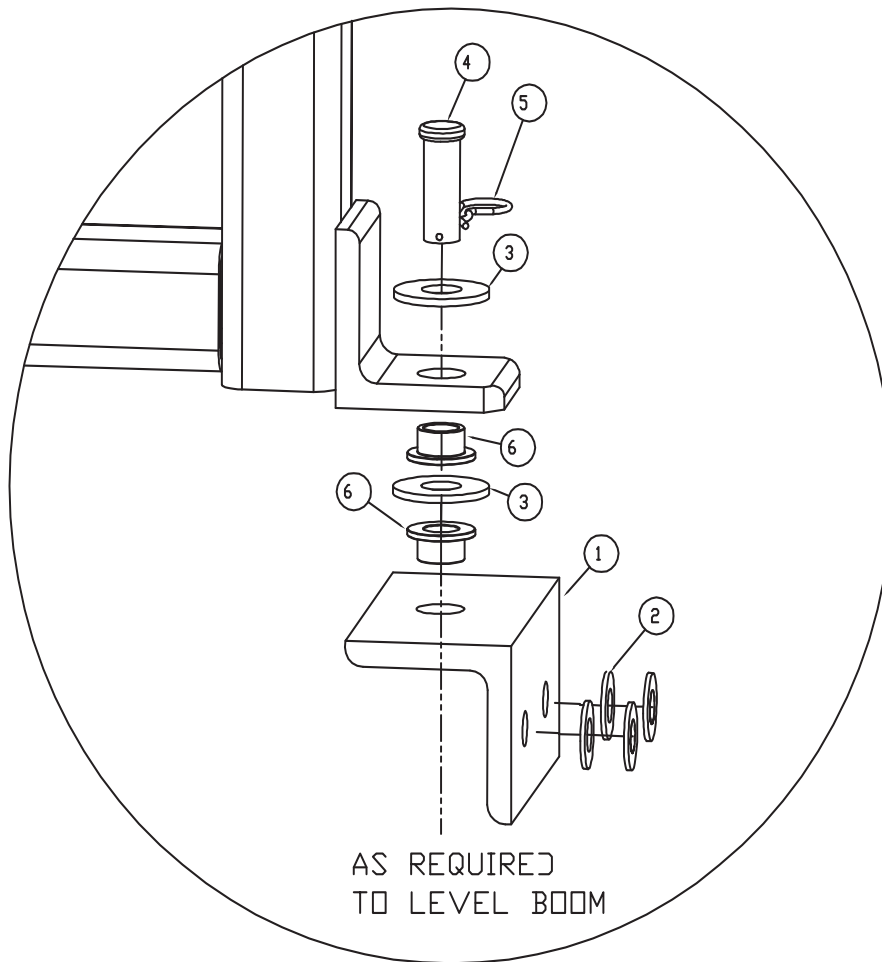
**BOTTOM BRACKET ASSEMBLY:  
JANUARY 2011 AND EARLIER ONLY  
WC 100, 150, 250, 500 & 1000 LBS**

**NOTE: As of June 2013, we are no longer using this assembly.  
The replacement assembly is K-WC-1000-R.**

K-WC-01			
ITEM	QTY.	PART NO.	DESCRIPTION
1	1	WCB1	BRACKET, ANGLE WALL CANTILEVER JIB
2	4	15-0004	5/8" FLAT WASHER
3	2	15-0005	FLAT WASHER, 3/4"
4	1	29-0003	PIN, CLEVIS 3/4" X 2 ZINC PLATED
5	1	29-0006	HAIRPIN COTTERS 5/8" - 3/4"
6	2	26-0009	BEARING, FLANGE 3/4"ID 841 BRNZ OILITE

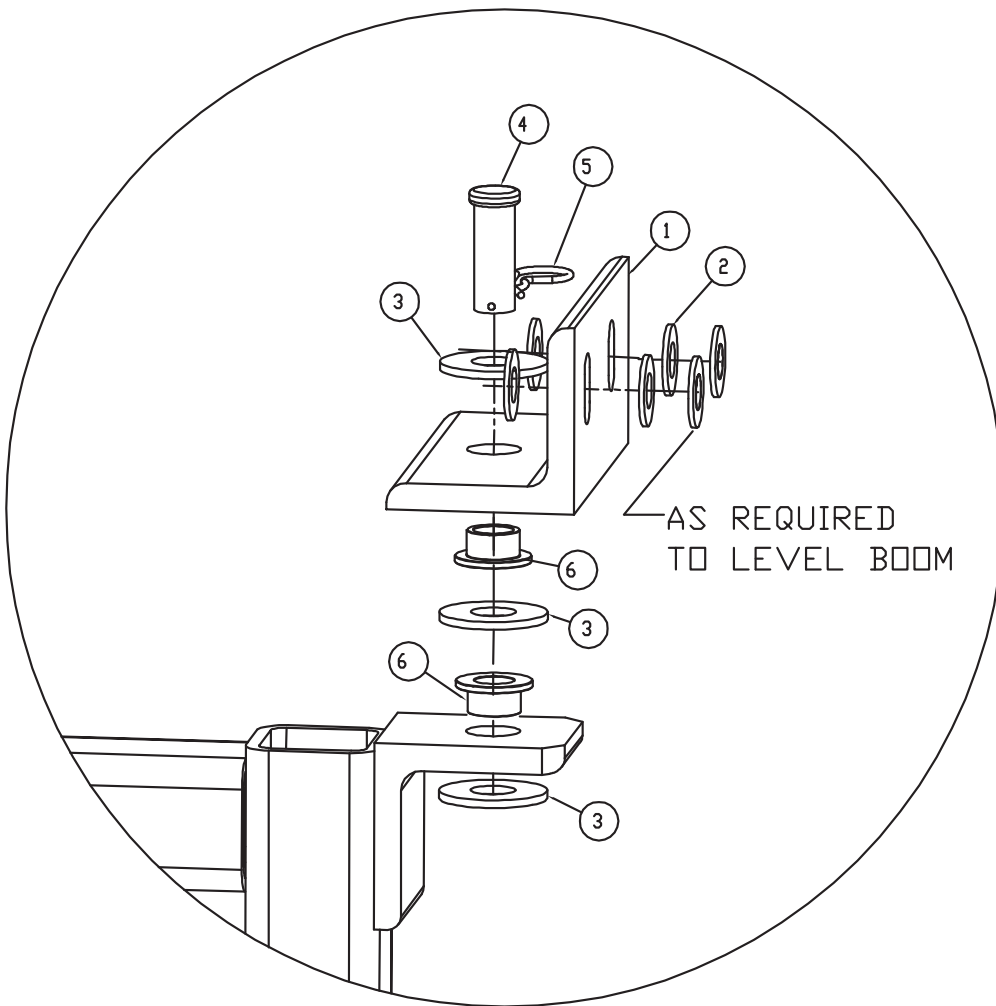
**TOP BRACKET ASSEMBLY:  
 JANUARY 2011 TO JUNE 2013  
 WC 100, 150, 250 & 500 LBS**

**NOTE: As of June 2013, we are no longer using this assembly.  
 The replacement assembly is K-WC-1000-R.**

K-WC-02			
ITEM	QTY.	PART NO.	DESCRIPTION
1	1	WCB2	BRACKET,SLOTTED ANGLE WALL CANT JIB
2	6	15-0004	5/8" FLAT WASHER
3	3	15-0005	FLAT WASHER, 3/4"
4	1	29-0003	PIN, CLEVIS 3/4" X 2 ZINC PLATED
5	1	29-0006	HAIRPIN COTTERS 5/8" - 3/4"
6	2	26-0023	BEARING, FLANGE 3/4ID,1"OD,954 BRNZ

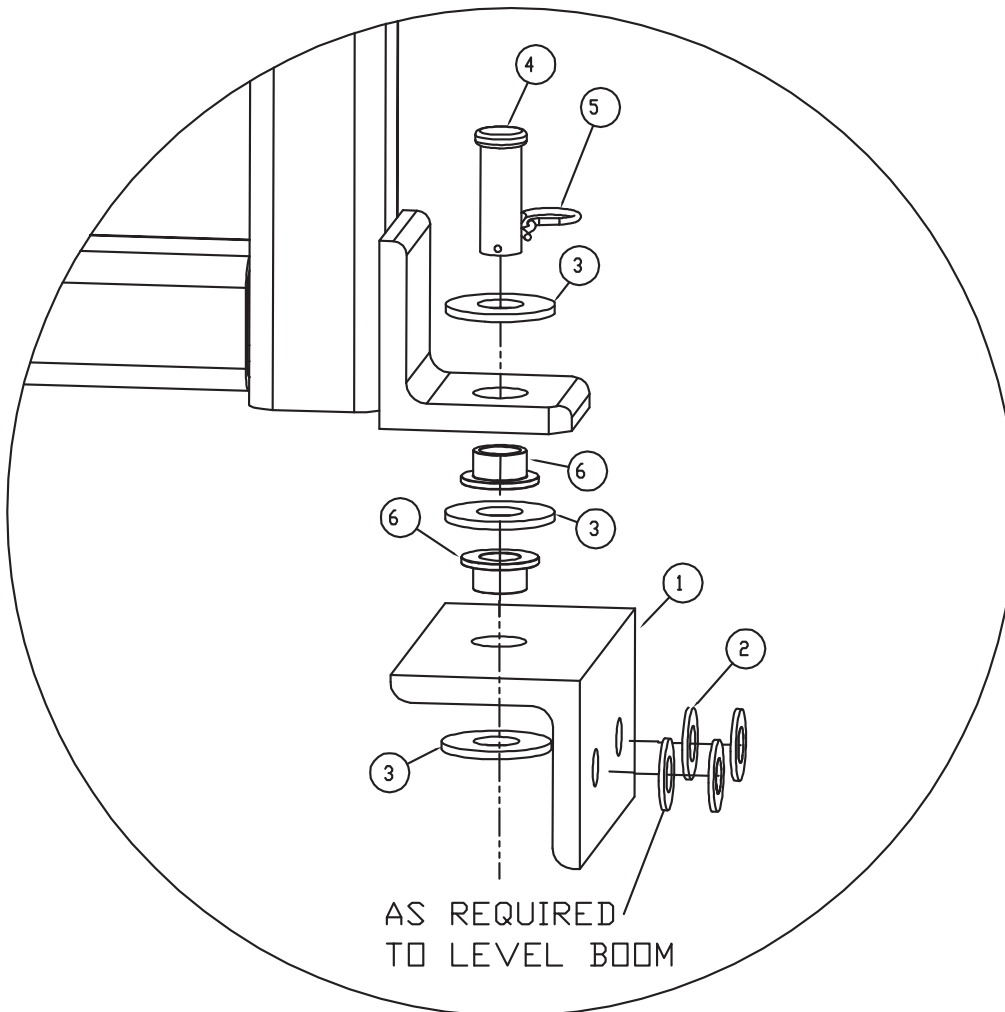
**BOTTOM BRACKET ASSEMBLY:  
 JANUARY 2011 TO JUNE 2013  
 WC 100, 150, 250 & 500 LBS**

**NOTE: As of June 2013, we are no longer using this assembly.  
 The replacement assembly is K-WC-1000-R.**

K-WC-02			
ITEM	QTY.	PART NO.	DESCRIPTION
1	1	WCB1	BRACKET, ANGLE WALL CANTILEVER JIB
2	4	15-0004	5/8" FLAT WASHER
3	3	15-0005	FLAT WASHER, 3/4"
4	1	29-0003	PIN, CLEVIS 3/4" X 2 ZINC PLATED
5	1	29-0006	HAIRPIN COTTERS 5/8" - 3/4"
6	2	26-0023	BEARING, FLANGE 3/4ID,1"OD,954 BRNZ

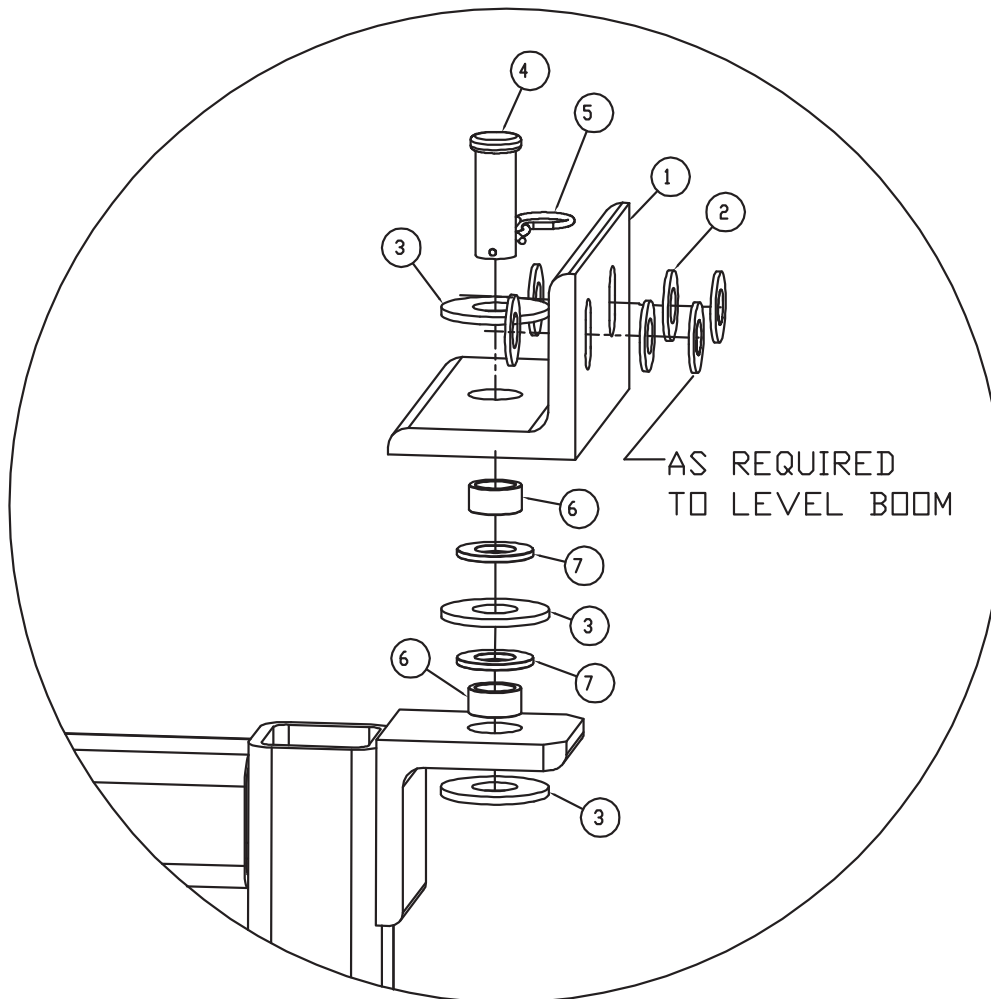
**TOP BRACKET ASSEMBLY:  
JANUARY 2011 TO JUNE 2013  
WC 1000 LBS**

**NOTE: As of June 2013, we are no longer using this assembly.  
The replacement assembly is K-WC-1000-R.**

K-WC-03			
ITEM	QTY.	PART NO.	DESCRIPTION
1	1	WCB2	BRACKET,SLOTTED ANGLE WALL CANT JIB
2	6	15-0004	5/8" FLAT WASHER
3	3	15-0005	FLAT WASHER, 3/4"
4	1	29-0003	PIN, CLEVIS 3/4" X 2 ZINC PLATED
5	1	29-0006	HAIRPIN COTTERS 5/8" - 3/4"
6	2	26-0025	BEARING, SLEEVE 3/4" ID,1"OD,1/2" LNPTH
7	2	26-0024	THRUST WASHER, 3/4" BRONZE SAE 841

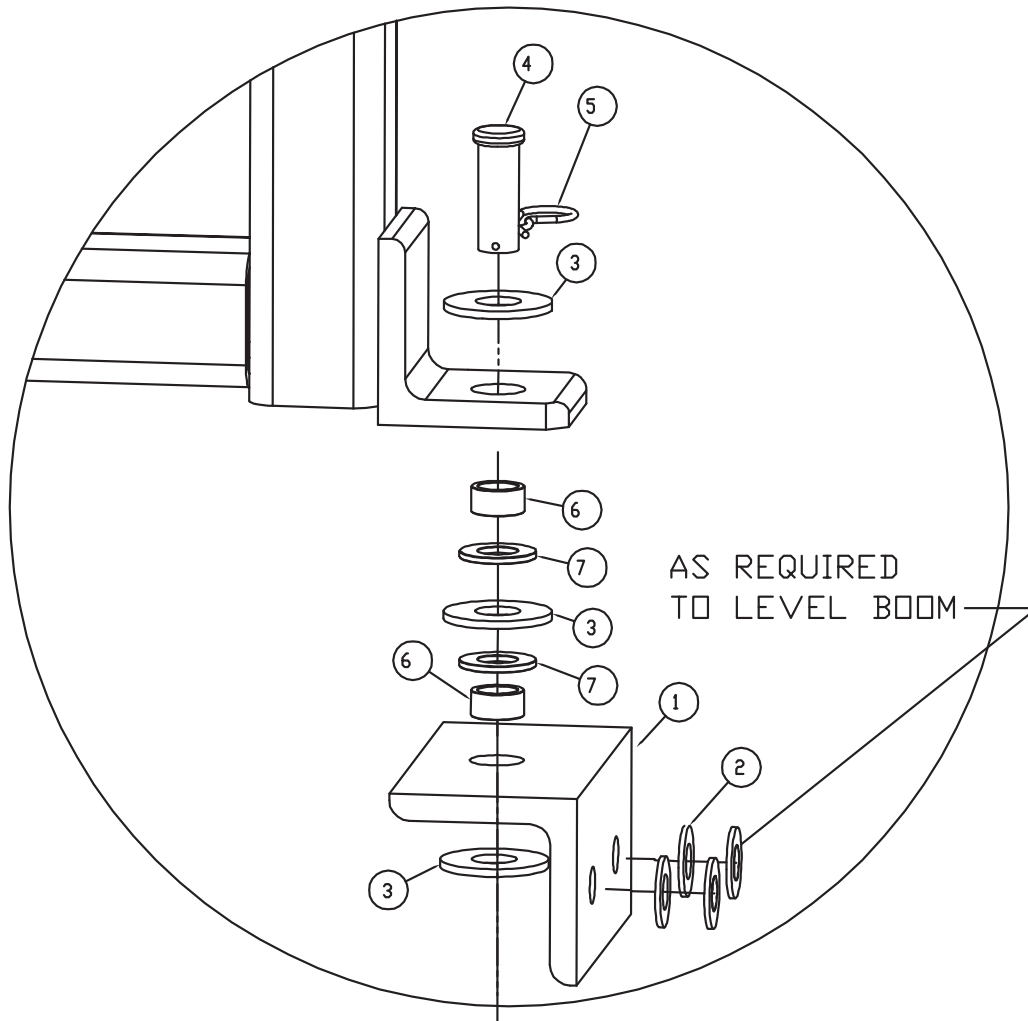
**BOTTOM BRACKET ASSEMBLY:  
JANUARY 2011 TO JUNE 2013  
WC 1000 LBS**

**NOTE: As of June 2013, we are no longer using this assembly.  
The replacement assembly is K-WC-1000-R.**

K-WC-03			
ITEM	QTY.	PART NO.	DESCRIPTION
1	1	WCB1	BRACKET, ANGLE WALL CANTILEVER JIB
2	4	15-0004	5/8" FLAT WASHER
3	3	15-0005	FLAT WASHER, 3/4"
4	1	29-0003	PIN, CLEVIS 3/4" X 2 ZINC PLATED
5	1	29-0006	HAIRPIN COTTERS 5/8" - 3/4"
6	2	26-0025	BEARING, SLEEVE 3/4" ID, 1" OD, 1/2" LENGTH
7	2	26-0024	THRUST WASHER, 3/4" BRONZE SAE 841

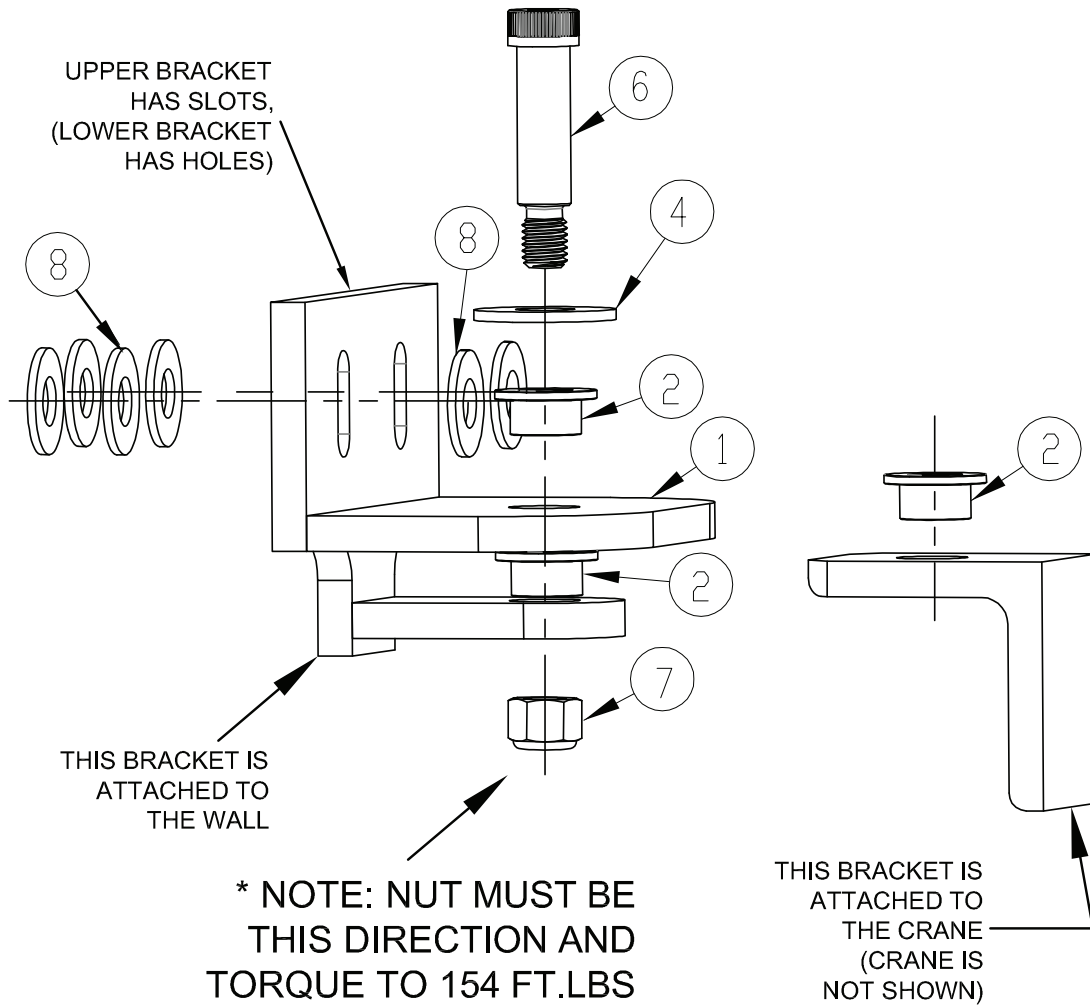
**TOP BRACKET ASSEMBLY:  
JUNE 2013 AND LATER ONLY (ALL WC'S)  
WC 100, 150, 250, 500, AND 1000 LBS**

**NOTE: This bracket assembly applies to all WC Jibs and replacement brackets June 2013 and later.**

K-WC-1000-R			
ITEM	QTY.	PART NO.	DESCRIPTION
1	1	9-5117	WC, UPPER BRACKET WELD
2	6	26-0023	BRONZE BUSHING
3	N/A	N/A	N/A
4	2	15-0005	FLAT WASHER, 3/4"
6	2	101-0221	SHOULDER BOLT, 3/4", 5/8"-11 NC, 2 1/4" LNG
7	2	13-0001	HEX LOCK NUT, 5/8"-11 NC
8	10	15-0004	5/8" FLAT WASHER

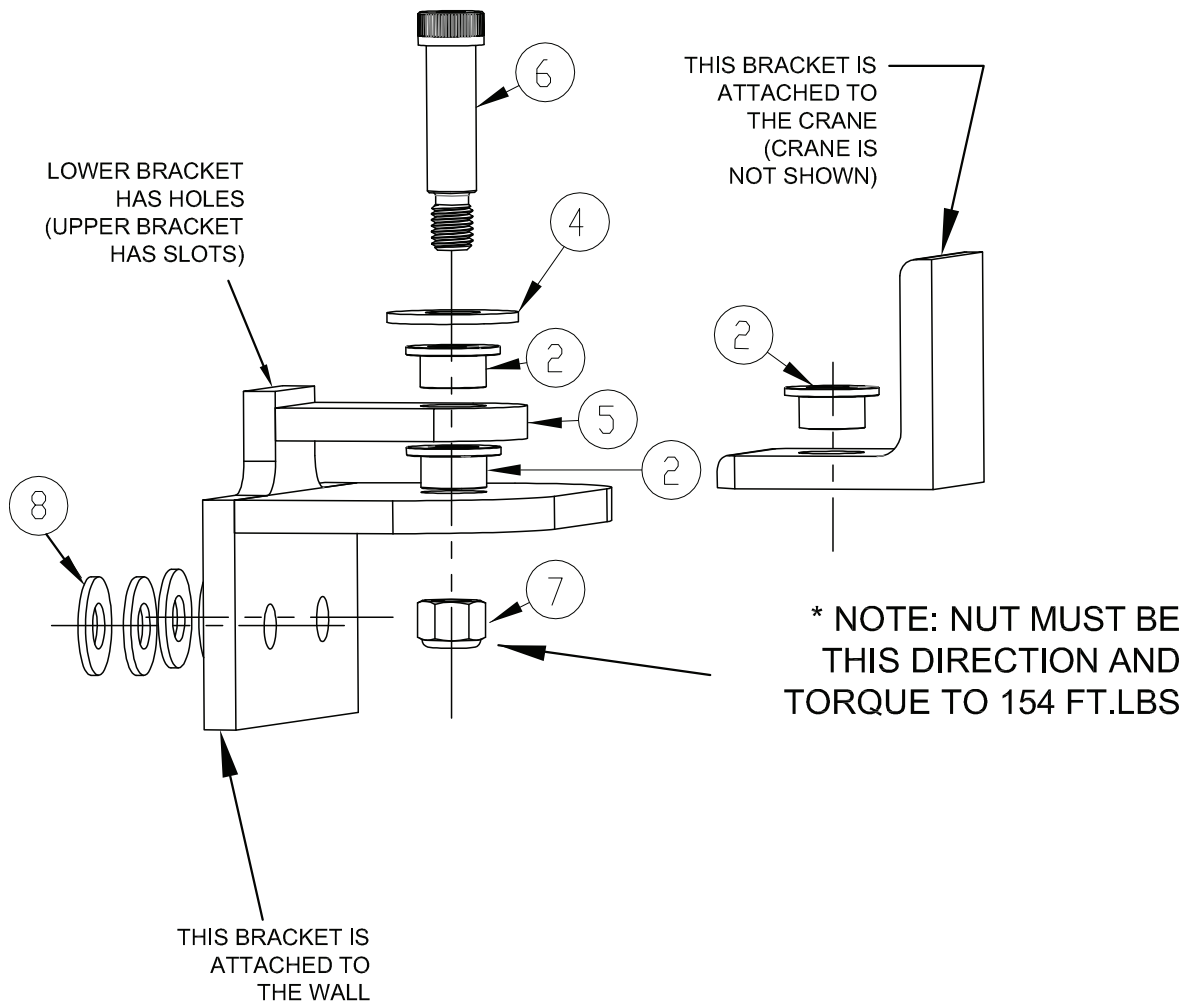
**BOTTOM BRACKET ASSEMBLY:  
JUNE 2013 AND LATER ONLY (ALL WC'S)  
WC 100, 150, 250, 500, AND 1000 LBS**

**NOTE: This bracket assembly applies to all WC Jibs and replacement brackets June 2013 and later.**

K-WC-1000-R			
ITEM	QTY.	PART NO.	DESCRIPTION
2	6	26-0023	BRONZE BUSHING
3	N/A	N/A	N/A
4	2	15-0005	FLAT WASHER, 3/4"
5	1	9-5116	WELD, WC, BRACK, LOWER ANGLE
6	2	101-0221	SHOULDER BOLT, 3/4", 5/8"-11 NC, 2 1/4" LNG
7	2	13-0001	HEX LOCK NUT, 5/8"-11 NC
8	10	15-0004	5/8" FLAT WASHER

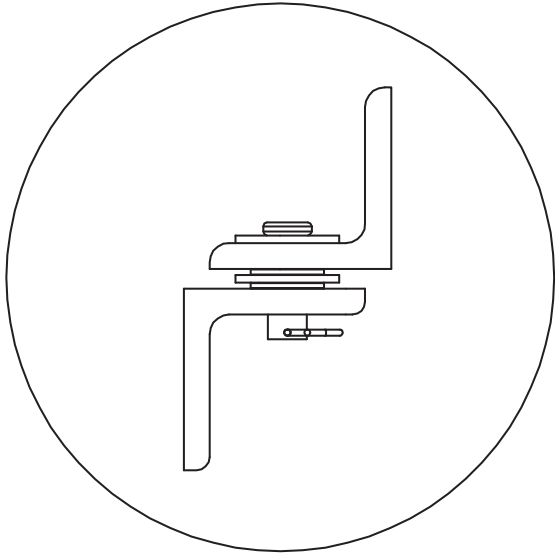
CORRECT

- Configuration for January 2011 and earlier
- All washers are installed and in the correct locations
- Flange bearings are not beginning to pull out and are installed in the correct locations
- Pin is down the whole way
- Cotter pin is present
- Angles and crane are aligned horizontally

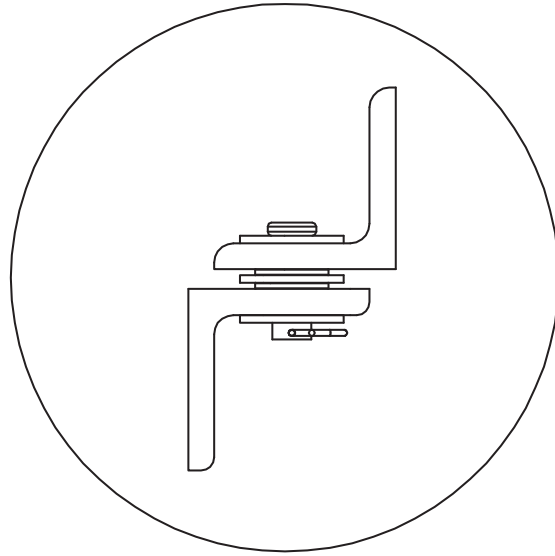
CORRECT

- Configuration for January 2011 to June 2013
- All washers are installed and in the correct locations
- Flange bearings are not beginning to pull out and are installed in the correct locations
- Pin is down the whole way
- Cotter pin is present
- Angles and crane are aligned horizontally

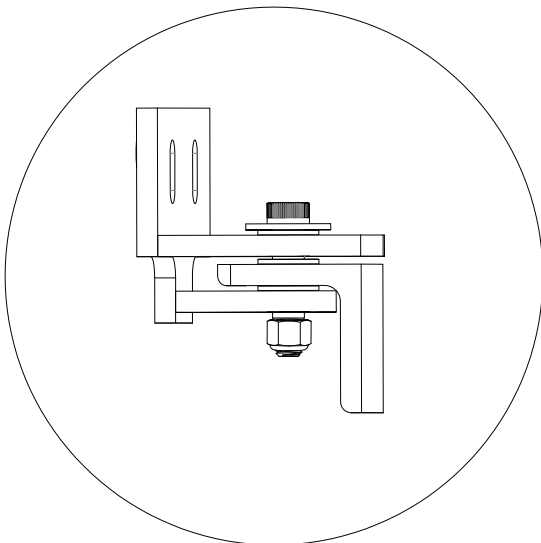
CORRECT

- Configuration for June 2013 and later
- All washers and flange bearings are present
- Angles and crane are aligned horizontally
- Lock nut is tightened to 10 ft/lbs
- Bearings are being loaded correctly and shoulder bolt is being stressed correctly

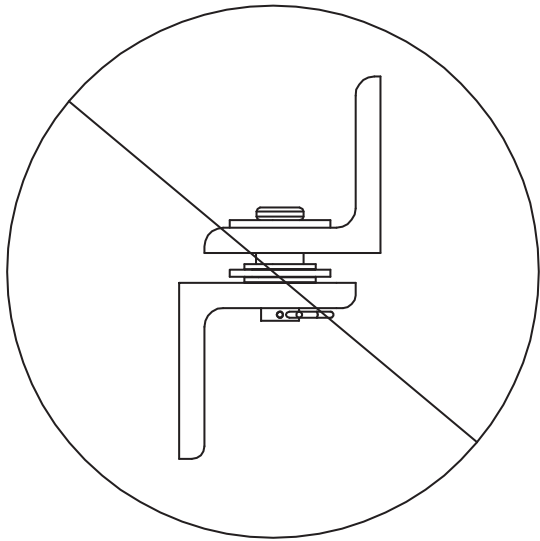
INCORRECT

- Crane must be taken out of service immediately
- Could result in serious injury or death

- The upper flange bearing is beginning to pull out
- Flange bearing may be wearing incorrectly
- Pin may be exposed to wear or failure if flange bearing pulls the entire way out

- Bracket centers are too large

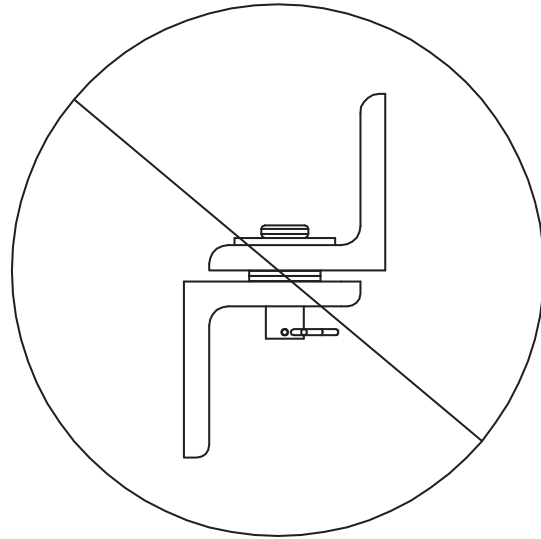
INCORRECT

- Crane must be taken out of service immediately
- Could result in serious injury or death

- Center washer is missing

- Incorrect installation

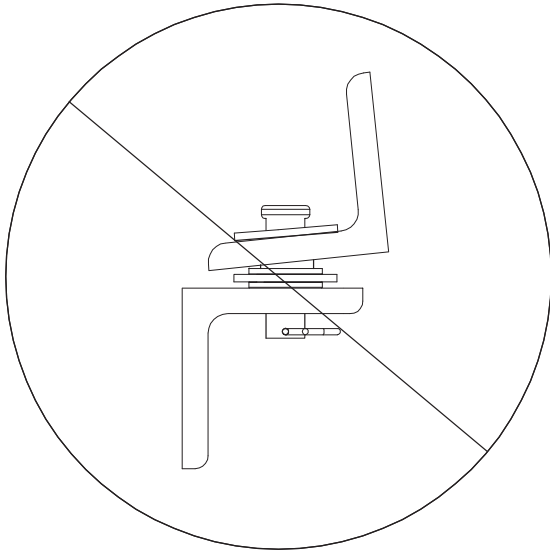
INCORRECT

- Crane must be taken out of service immediately
- Could result in serious injury or death

- Angles or crane are misaligned
- Pin is beginning to pull out
- Upper flange bearing may be beginning to pull out
- Flange bearing may be wearing incorrectly
- Upper portion of pin may be exposed to wear or failure due to misalignment

- Bracket not mounted correctly

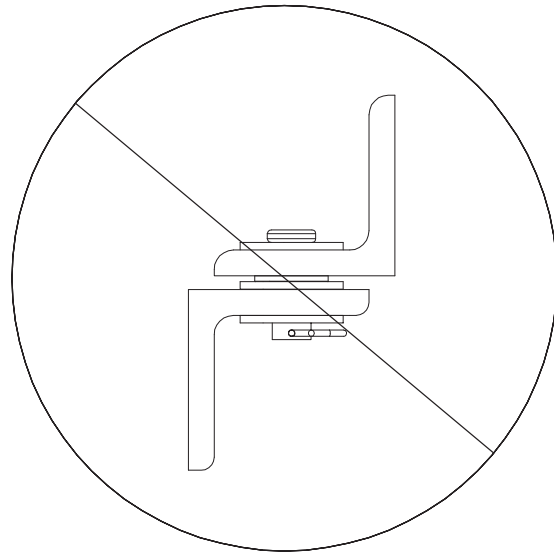
INCORRECT

- Crane must be taken out of service immediately
- Could result in serious injury or death

- Lower flange bearing is missing entirely
- Angle will be wearing directly on pin without the protection of the bearing
- Pin will prematurely fail

- Lower flange bearing is missing entirely (incorrect installation)
- Bracket centers are less than required

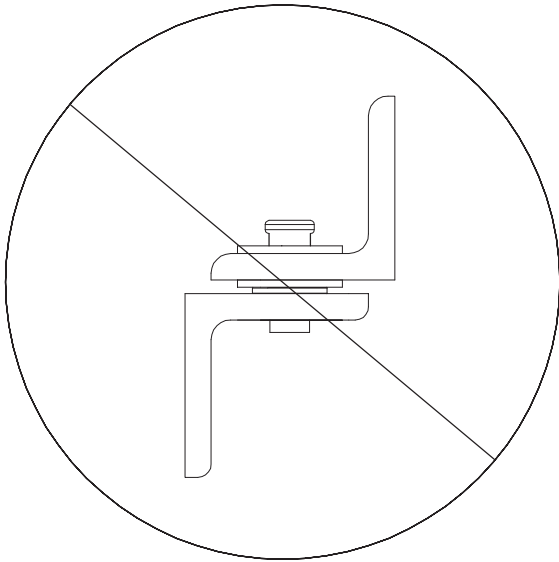
INCORRECT

- Crane must be taken out of service immediately
- Could result in serious injury or death

- Upper flange bearing is missing entirely
- Angle will be wearing directly on pin without the protection of the bearing
- Pin will prematurely fail
- The cotter pin is missing entirely
- The pin is beginning to work its way out of its proper location

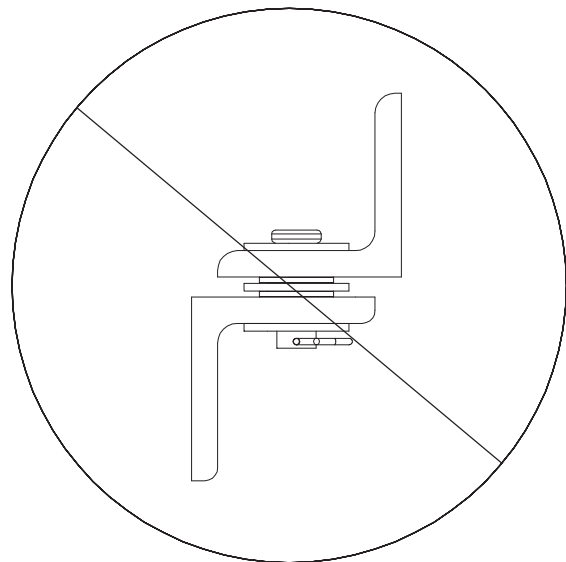
INCORRECT

- Configuration for January 2011 to June 2013
- Although this figure looks identical to the correct configuration, there may be sleeve bearings that are missing for the 1,000 LB crane
- The thrust bearings are obviously here, but the sleeve bearings may or may not be present. A closer inspection would be necessary to determine if the sleeve bearings are present or not

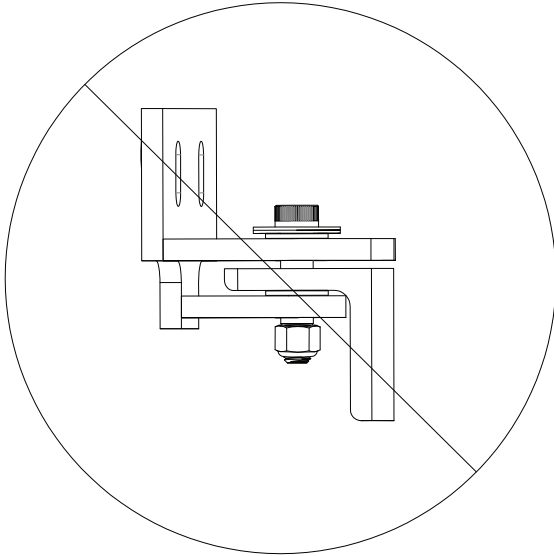
**INCORRECT**

- Crane must be taken out of service
- Could result in serious injury or death

- Center bronze bushing is missing

- Incorrect installation

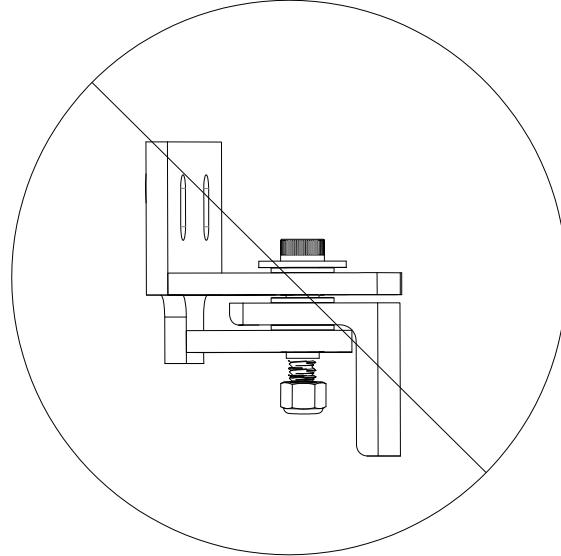
**INCORRECT**

- Crane must be taken out of service
- Could result in serious injury or death

- Shoulder bolt nut is not tightened

- Incorrect installation
